# IonWorks Barracuda<sup>®</sup>

Automated Patch Clamp System

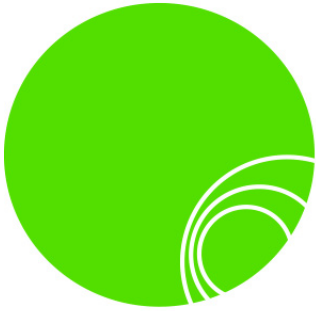
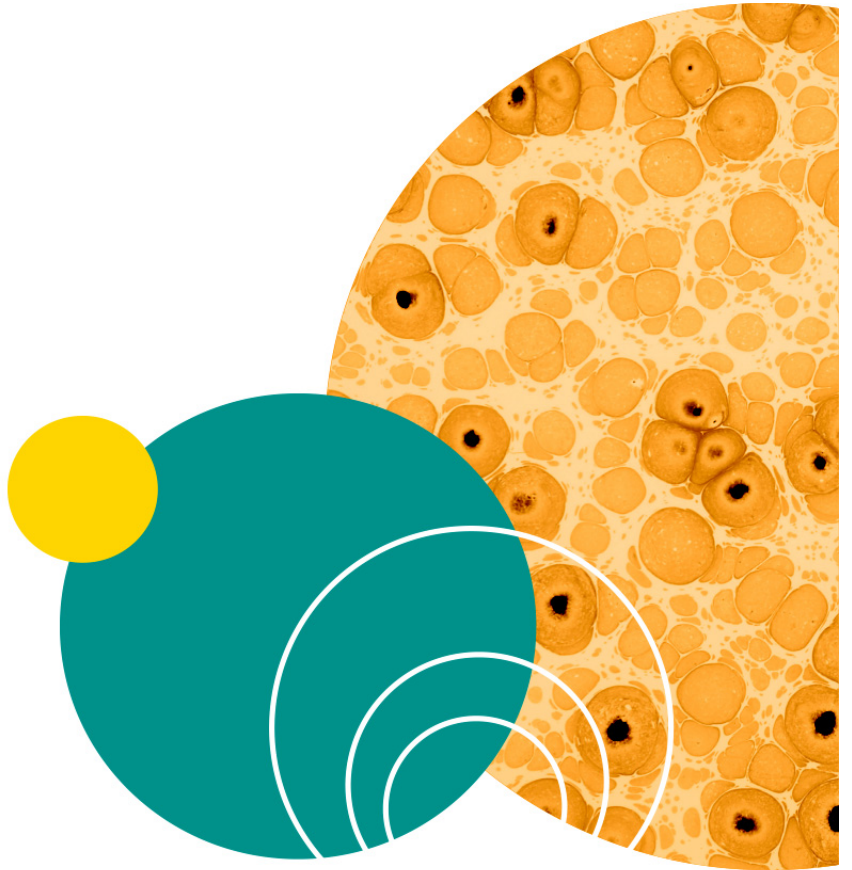
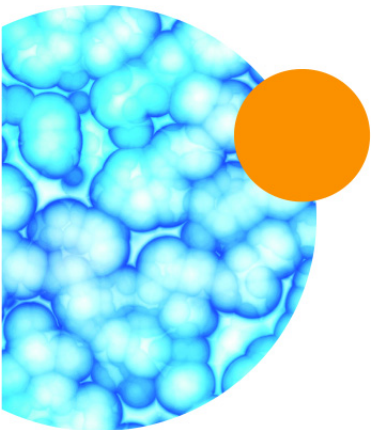
# IonWorks Barracuda Software Version 2.5 Software Release Notes
